Experimental assessment of the seismic response of three-leaf stone masonry walls, with due consideration to soil–structure interaction

A.-A. Manoledaki, V. Drosos, I. Anastasopoulos, E. Vintzileou & G. Gazetas

National Technical University of Athens, Greece

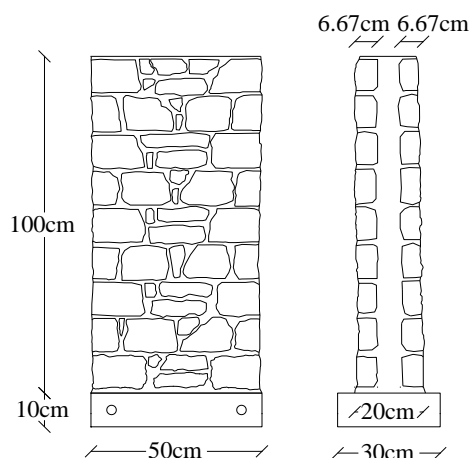
Figure 1. Schematic geometry of the test specimens.

The specimens represent walls typically found in historic three-leaf stone masonry structures. A reduced scale of 1:3 was adopted for the tests. As can be seen in Figure 1, each wall specimen (0.5 m

long, 0.2 m thick and 1.0 m high) was built on top of a spread concrete footing (0.5 m long, 0.3 m wide and 0.1 m high) which ran along the entire wall length.

The walls were constructed by a professional mason, following the traditional building procedure. They consist of two external leaves, built simultaneously as separate walls, and a loose poor quality incoherent inner core. The external leaves were made of nine courses of rubble limestone bonded with lime-pozzolan based mortar. As confirmed by the results of the conducted standardized tests, the constitutive materials were representative of those found in historic structures. The infill material was prepared on site by mixing stone fragments with binding mortar. Subsequently, it was poured in the gap between the external leaves without compaction, thereby achieving a voids ratio of 40% to 45%. The leaves had approximately the same thickness (i.e., $t_w/3 = 6.67$ cm), and no transversal connection was provided between them (non-monolithic behavior within the wall thickness).

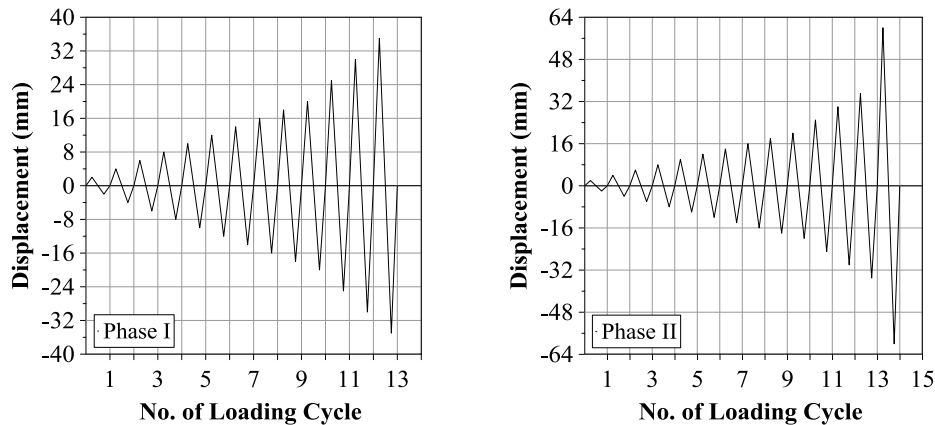
Figure 2. Cyclic loading displacement histories.

All tests were conducted at the facilities of the NTUA Soil Mechanics Laboratory. As presented in Table 1, the experimental program was divided in two phases. The initial phase involved a set of pushover tests ignoring SFSI. Then, during the second phase, the specimens were founded on a dry sand layer pluviated inside a rigid soil container, so as to investigate the role of SFSI. *Longstone* sand, an industrially produced fine and uniform quartz sand with $D_{50} = 0.15$ mm and uniformity coefficient $C_u = 1.42$ was used in the experiments. Its characteristics have been documented in Anastasopoulos et al., [2010]. The sand was pluviated through an electronically-controlled sand raining system, capable of producing sand specimens of controllable relative density D_r . Two idealized soil deposits were modelled, in order to examine the effect of soil resilience: (a) dense sand of $D_r = 92\%$, and (b) loose sand of $D_r = 33\%$. Monotonic and cyclic out-of-plane loading was imposed at wall mid-height, by means of a servo-electric screw-jack actuator. Tests were performed under displacement control, at an increment rate of 0.2 mm/s. The prescribed cyclic displacement protocols are given in Figure 2.

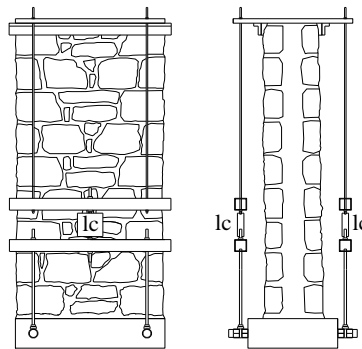
Figure 3. Post-tensioning system used to strengthen specimen W3.

While most of the specimens were tested as built, specimen W3 was tested in strengthened condition. Strengthening against out-of-plane bending was imposed through a post-tensioning system (see Figure 3) which induced a couple of constantly monitored resisting forces.

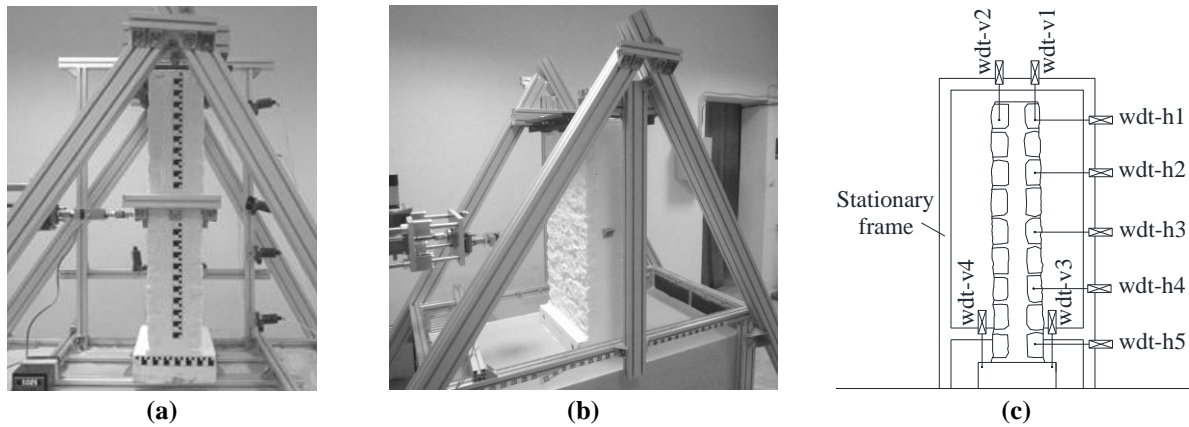
Figure 4. Test set-up: (a) phase I configuration, (b) phase II configuration, and (c) wdt's arrangement.

Depending on the features of the stone masonry structure, in reality, there is a certain degree of variability regarding the translational and rotational restraint provided to the walls. It is well known that timber floors and roof do not represent a *rigid* diaphragm, and do not provide fixed connection with the walls. Hence, for accurate more realistic representation of the wall boundary conditions typically encountered in historic structures an adjustable test rig was expressly designed to allow rotation of the wall crest while restrain its translational motion. The sensitivity of the out-of-plane response against wall boundary conditions was examined through the subsequently presented two cases. The test rig configuration used during phase I (see Figure 4a) aimed at representing the case of walls whose elongation is partially obstructed by the floor or roof. In phase II, as can be seen in Figure 4b, two essential alterations were made at the test rig: (a) the wall–footing specimen was founded directly on the sand layer, and (b) the top support was modified to allow for vertical movement due to footing settlement. It should be noted that all the walls were free along their vertical edges.

Regarding the instrumentation, wall displacements were recorded by nine wire displacement transducers (wdt's) mounted on a stationary frame (see Figure 4c). In particular, horizontal displacements were measured at key locations along the wall height (i.e., at courses 1, 3, 5, 7 and 9), while vertical displacements were measured at two points at both the footing and the wall crest so that the rotation of the wall ends to be estimated. The force applied by the actuator was measured using a load cell (lc). In the case of the strengthened specimen W3, two additional load cells were attached to

the post-tensioning system in order to monitor the couple of developing forces. Soil–foundation interaction was monitored at all times, through the transparent soil container, via a digital camera. The post-test surface relief of the sand layer was obtained with the help of a laser displacement transducer (ldt) travelling above the surface along the mid-axis of the footing.

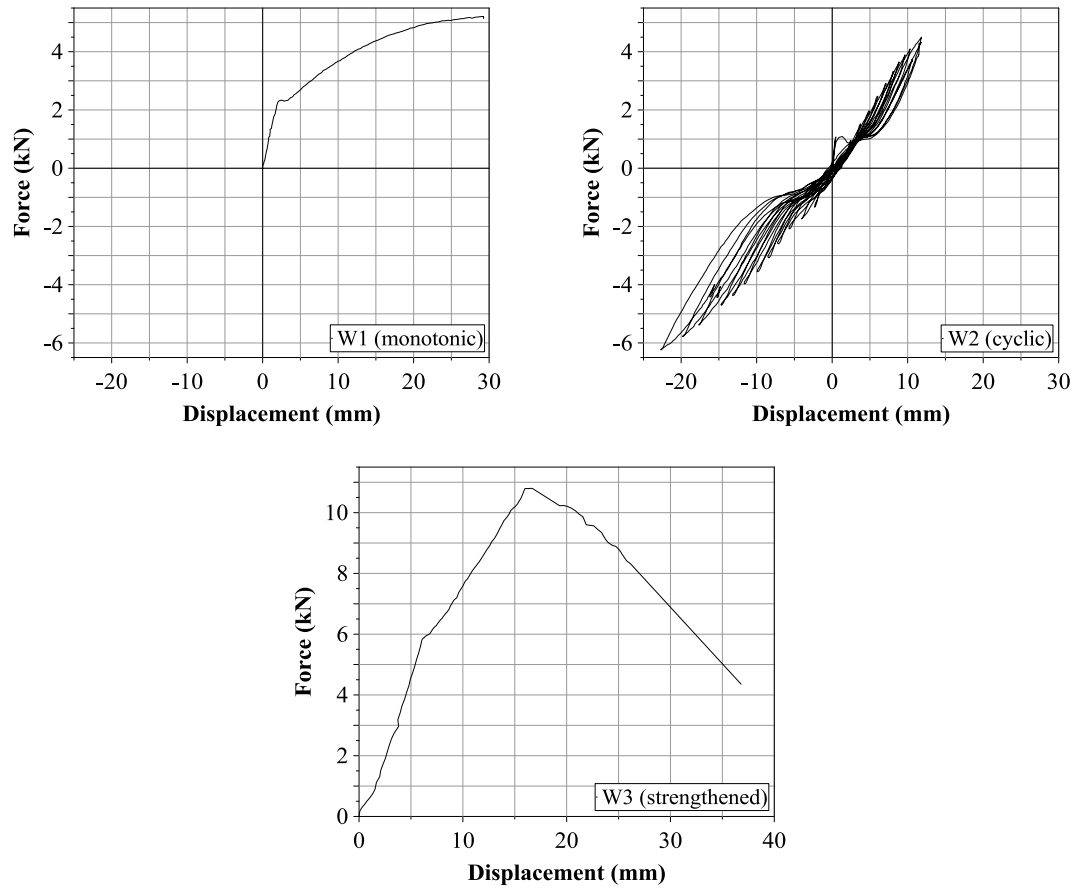
Figure 5. Force–displacement response comparison for phase I tests.

The results of phase I tests are summarized in Figure 5. The resisting force is plotted against the applied displacement at wall mid-height. For comparison purposes, common axis scales were used for specimens W1 (monotonic test) and W2 (cyclic test), which were tested as built. The data are also summarized in Table 2.

Inspection of the force–displacement curves indicates a consistency in the general response trends of control specimens W1 and W2. The onset of cracking (F_{cr} , Δ_{cr}), at the extreme tensile fibers of the critical section, signified the end of the initial linear-elastic response stage. Afterwards, the walls continued to resist with increasing force and degrading stiffness, until peak force (F_{max} , $\Delta_{F_{max}}$) was reached. This increased flexural bending resistance is attributed to the beneficial effect of the axial load induced by the top support which restrains the vertical movement. In the course of the test, while imposed displacement amplitude progressively increased, the wall had the tendency to elongate (due to arching). However, as it was partially restrained by the top support, it was subjected to an additional axial load which resulted in higher axial strength. The significant effect of boundary conditions on the out-of-plane response of the tested walls becomes even more evident when the attained F_{cr} and F_{max} values are compared.

In the case of the cyclically loaded specimen W2, there is an obvious asymmetry of the force–displacement data in the positive and negative displacement directions. This could be attributed to the fact that cracking initiated earlier in the positive displacement direction (i.e., an entire loading cycle ahead) and therefore, as a result of the higher damage accumulation level, the respective wall side was weakened more rapidly.

The force–displacement response of the strengthened specimen W3 was substantially improved, due to the couple of resisting forces induced by the post-tensioning system. As shown by the test results (Figure 5; Table 2), its out-of-plane resistance was practically doubled in comparison with control specimens W1 and W2. Hence, the specific strengthening technique proved to be highly effective against out-of-plane actions.

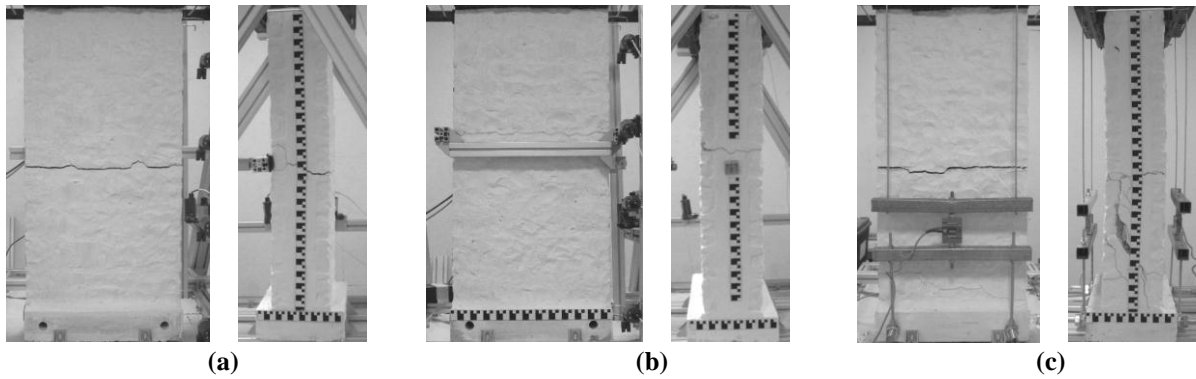
Figure 6. Post-test crack patterns observed on specimen: (a) W1, (b) W2, and (c) W3.

Regarding the failure modes, one-way vertical out-of-plane bending was observed for control specimens W1 and W2. Material crushing was restricted to the weak mortar joints. In particular, flexural tensile cracks formed at the bed joints right below and right above the wall mid-height respectively (see Figures 6a and 6b) where the maximum strain is concentrated. Increasing displacements led to further crack propagation and widening, with the maximum crack width observed during the tests reaching approximately 12 mm.

The strengthened specimen W3 exhibited a slightly different crack pattern (see Figure 6c). As in the case of the monotonically tested W1, initially a main flexural tensile crack formed at the bed joint right below the wall mid-height. However, further crack propagation and widening was distinctly delayed due to the beneficial effect of the strengthening technique. In the course of the test, the aforementioned crack propagated across the wall thickness and reached a maximum width of about 7 mm. In addition, the pattern was supplemented by: (a) a stepped crack at the bottom course of the front side, (b) a horizontal crack along the bed joint above the bottom course of the back side, and (c) a group of diagonal cracks extending at the lower half of the two vertical edges, all indications of the increased axial stressing of the wall.

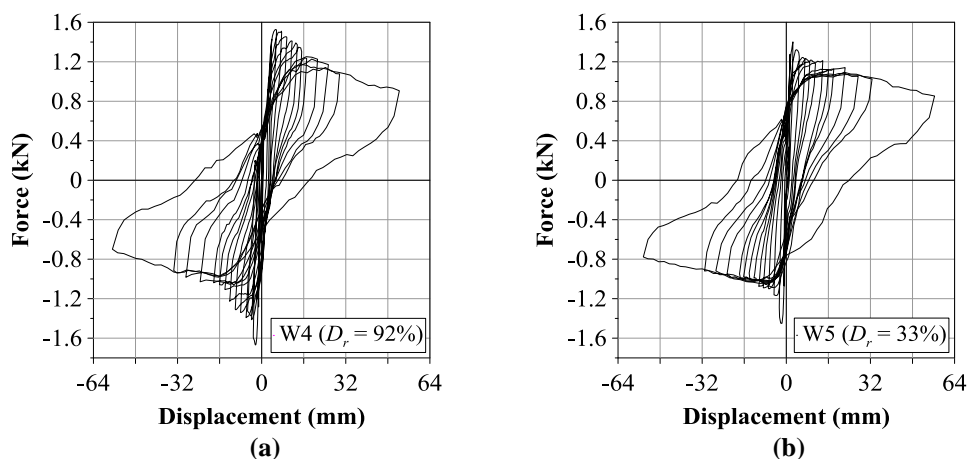
Figure 7. Force–displacement response for phase II tests: (a) dense sand, and (b) loose sand.

Figure 7 presents the force–displacement (at wall mid-height) response obtained during phase II tests, while the corresponding key data are summarized in Table 3. As expected, the initial linear-elastic response stage was followed by post-cracking cycles associated with strength and stiffness degradation, as a result of damage accumulation. Nevertheless, the results reveal that the performance of the walls was substantially affected by soil–foundation–structure interaction. The wall founded on dense sand exhibits higher strength than the one on loose sand. However, it is worthy to note that the residual strength of the wall seems to be independent of the soil stiffness. The walls exhibited substantial displacement capacity, as they were pushed to displacements close to the external leaf thickness (i.e., 67 mm); the maximum recorded displacements (Δ_{max}) were well in excess of the displacements at which cracking took place and peak force was attained (Δ_{cr}). It should be noted that the comparative test results of phases I and II, verify the sensitivity of the out-of-plane behavior of the walls to the boundary conditions. As expected, due to the beneficial effect of the additional axial load induced by the top support, specimens W1 and W2 significantly outperformed specimens W4 and W5. More specifically, while specimens W1 and W2 showed an increasing strength with displacement, specimens W4 and W5 exhibit degradation on both strength and stiffness.

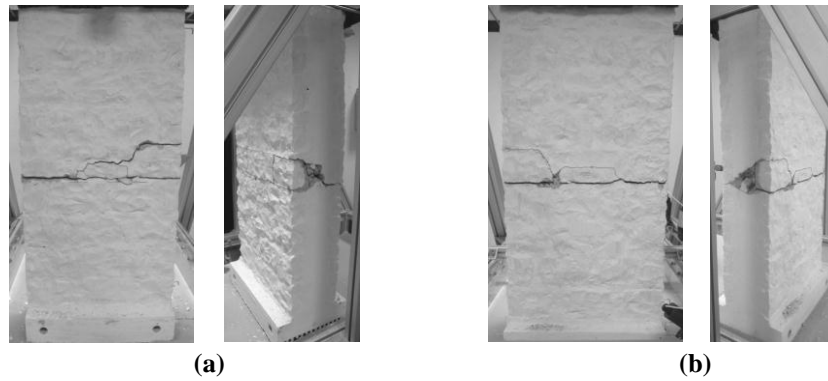
Figure 8. Post-test crack patterns observed on specimen: (a) W4, and (b) W5.

With respect to the failure modes, one-way vertical out-of-plane bending was observed for both walls. The post-test crack patterns can be seen in Figure 8. Material crushing was limited to the weak mortar joints, while the stones themselves remained elastic. Flexural tensile cracks formed at the bed joints right below and right above the wall mid-height. Further crack propagation and widening took place in the course of sequential loading cycles. The maximum crack width observed during the tests was about 35 mm for specimen W4, and 39 mm for specimen W5 respectively. It should be noted that the sustained damage was so extensive that the walls almost failed due to partial out-of-plane collapse.

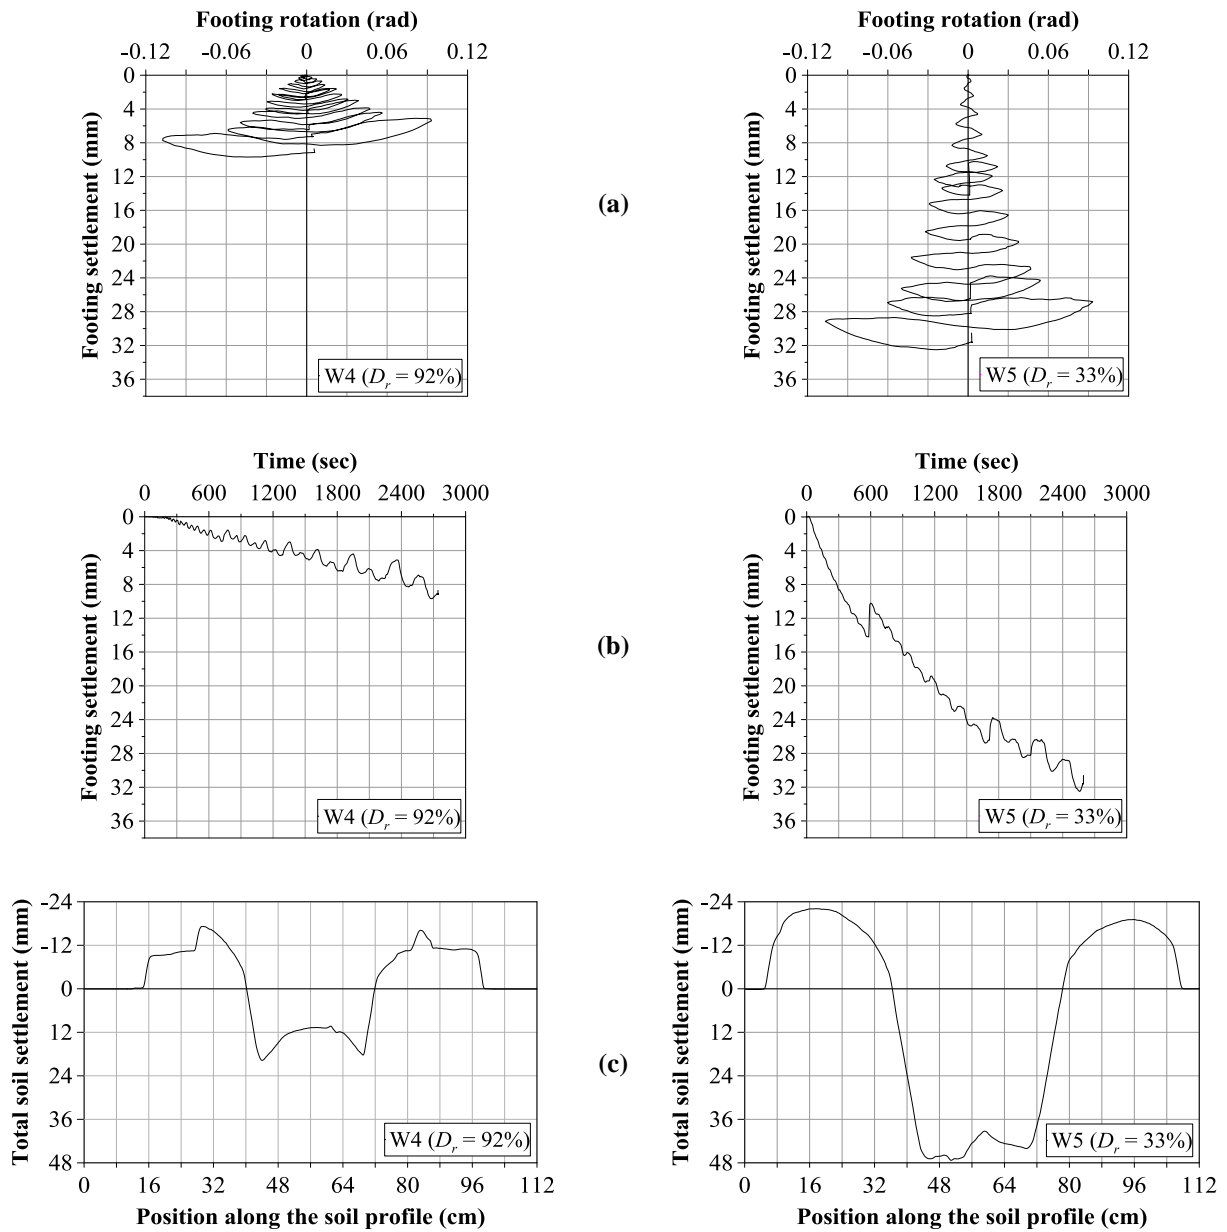
Figure 9. Comparative results for phase II tests: (a) footing settlement–rotation response, (b) time history of footing settlement, and (c) post-test soil deformation profile.

Figure 9 presents comparative test results associated with soil–foundation interaction, in terms of: (a) footing settlement–rotation response, (b) evolution of footing settlement in time, and (c) post-test soil deformation, as measured along the mid-axis of the footing. Note that settlement is denoted positive.

A combination of foundation rocking and soil bearing capacity mobilization was observed. The recorded time history of footing settlement verified that sequential loading cycles lead to settlement accumulation underneath the footings. As expected, soil resilience has a substantial influence on the performance of the soil–foundation–wall system.

Besides the obvious difference in the amount of settlement, the two soil materials reveal another disparity in their behavior: evidently, the footing on the dense sand layer experiences significant uplifting at each loading cycle, indicated by the ascending slope of the settlement–rotation ($w-\theta$) curves of Figure 9a [the gradient of $w-\theta$ curve indicates whether the foundation midpoint loses contact with the supporting soil as the foundation rotates, giving evidence on the amount of uplift that takes place during the test]. On the contrary, specimen W5 exhibits a *sinking* response. Interestingly however, the $w-\theta$ gradient of the latter foundation reverses after a few cycles of loading, showing upward movement of the foundation midpoint, and hence reduction of the minimum soil–foundation contact area, possibly as a result of sand densification (i.e., compaction) under the oscillating footing.

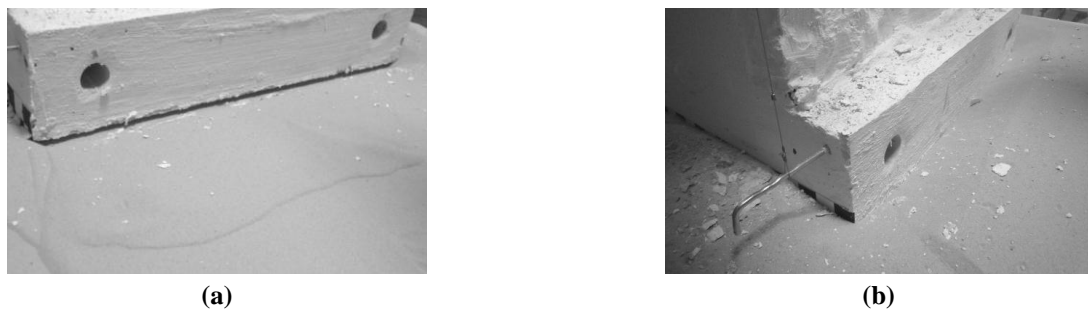
Figure 10. Post-test footing close-up photos: (a) dense sand (evident generated gap), and (b) loose sand.

Foundation rocking gradually led to loss of contact between the soil and the footing close to its edges, where intense uplifting took place, in the case of dense sand. The formed gap, where the footing is detached from the underlying soil, is clearly visible in the close-up photo of Figure 10a which was taken after test completion. Inspection of Figure 9c reveals a recorded arc-shaped soil surface formation beneath the footing of specimen W4. The specific finding proves that the gaps generated at the front and the back of the footing were associated with a reduction of its effective width. The aforementioned phenomenon did not take place in the case of loose sand, where the performance was sinking-dominated. The close-up photo of Figure 10b illustrates that at the end of the test the footing was partially embedded in the loose soil.
