Experimental assessment of the seismic response of three-leaf stone masonry walls, with due consideration to soil–structure interaction

A.-A. Manoledaki, V. Drosos, I. Anastasopoulos, E. Vintzileou & G. Gazetas

National Technical University of Athens, Greece

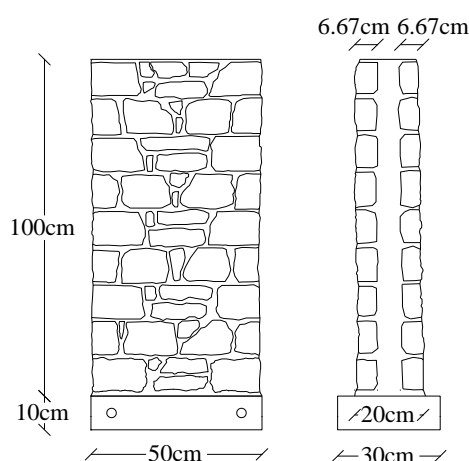
Figure 1. Schematic geometry of the test specimens.

The specimens represent walls typically found in historic three-leaf stone masonry structures. A reduced scale of 1:3 was adopted for the tests. As can be seen in Figure 1, each wall specimen (0.5 m

long, 0.2 m thick and 1.0 m high) was built on top of a spread concrete footing (0.5 m long, 0.3 m wide and 0.1 m high) which ran along the entire wall length.

The walls were constructed by a professional mason, following the traditional building procedure. They consist of two external leaves, built simultaneously as separate walls, and a loose poor quality incoherent inner core. The external leaves were made of nine courses of rubble limestone bonded with lime-pozzolan based mortar. As confirmed by the results of the conducted standardized tests, the constitutive materials were representative of those found in historic structures. The infill material was prepared on site by mixing stone fragments with binding mortar. Subsequently, it was poured in the gap between the external leaves without compaction, thereby achieving a voids ratio of 40% to 45%. The leaves had approximately the same thickness (i.e., $t_w/3 = 6.67$ cm), and no transversal connection was provided between them (non-monolithic behavior within the wall thickness).

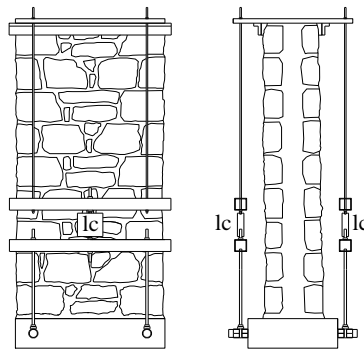
Figure 3. Post-tensioning system used to strengthen specimen W3.

While most of the specimens were tested as built, specimen W3 was tested in strengthened condition. Strengthening against out-of-plane bending was imposed through a post-tensioning system (see Figure 3) which induced a couple of constantly monitored resisting forces.

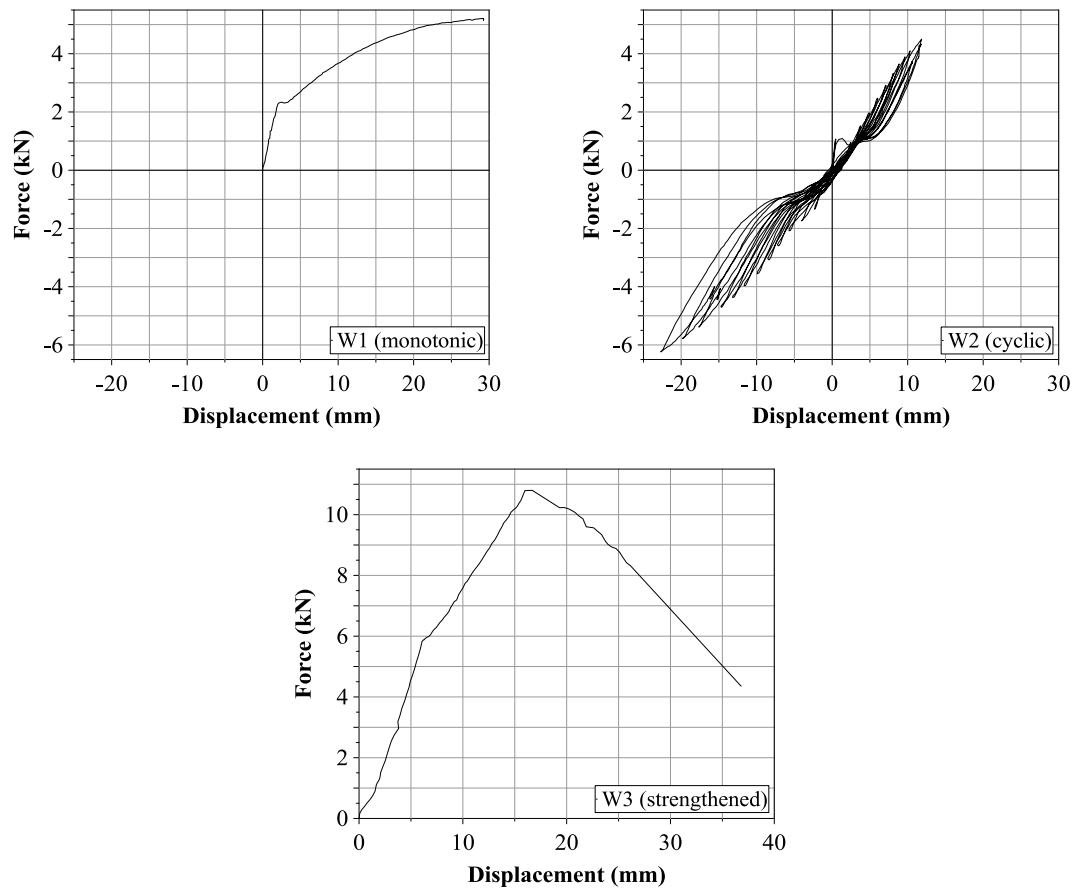
Figure 5. Force–displacement response comparison for phase I tests.

The results of phase I tests are summarized in Figure 5. The resisting force is plotted against the applied displacement at wall mid-height. For comparison purposes, common axis scales were used for specimens W1 (monotonic test) and W2 (cyclic test), which were tested as built. The data are also summarized in Table 2.

Inspection of the force–displacement curves indicates a consistency in the general response trends of control specimens W1 and W2. The onset of cracking (F_{cr} , Δ_{cr}), at the extreme tensile fibers of the critical section, signified the end of the initial linear-elastic response stage. Afterwards, the walls continued to resist with increasing force and degrading stiffness, until peak force (F_{max} , $\Delta_{F_{max}}$) was reached. This increased flexural bending resistance is attributed to the beneficial effect of the axial load induced by the top support which restrains the vertical movement. In the course of the test, while imposed displacement amplitude progressively increased, the wall had the tendency to elongate (due to arching). However, as it was partially restrained by the top support, it was subjected to an additional axial load which resulted in higher axial strength. The significant effect of boundary conditions on the out-of-plane response of the tested walls becomes even more evident when the attained F_{cr} and F_{max} values are compared.

In the case of the cyclically loaded specimen W2, there is an obvious asymmetry of the force–displacement data in the positive and negative displacement directions. This could be attributed to the fact that cracking initiated earlier in the positive displacement direction (i.e., an entire loading cycle ahead) and therefore, as a result of the higher damage accumulation level, the respective wall side was weakened more rapidly.

The force–displacement response of the strengthened specimen W3 was substantially improved, due to the couple of resisting forces induced by the post-tensioning system. As shown by the test results (Figure 5; Table 2), its out-of-plane resistance was practically doubled in comparison with control specimens W1 and W2. Hence, the specific strengthening technique proved to be highly effective against out-of-plane actions.

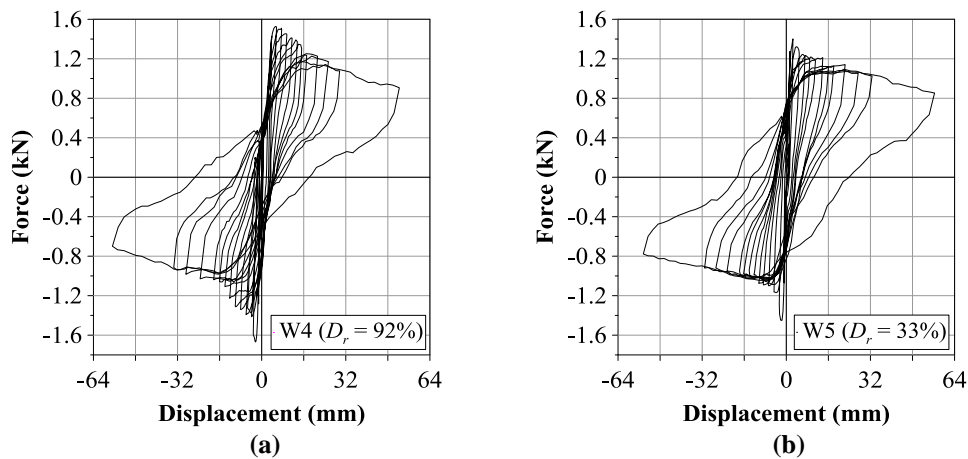
Figure 7. Force–displacement response for phase II tests: (a) dense sand, and (b) loose sand.

Figure 7 presents the force–displacement (at wall mid-height) response obtained during phase II tests, while the corresponding key data are summarized in Table 3. As expected, the initial linear-elastic response stage was followed by post-cracking cycles associated with strength and stiffness degradation, as a result of damage accumulation. Nevertheless, the results reveal that the performance of the walls was substantially affected by soil–foundation–structure interaction. The wall founded on dense sand exhibits higher strength than the one on loose sand. However, it is worthy to note that the residual strength of the wall seems to be independent of the soil stiffness. The walls exhibited substantial displacement capacity, as they were pushed to displacements close to the external leaf thickness (i.e., 67 mm); the maximum recorded displacements (Δ_{max}) were well in excess of the displacements at which cracking took place and peak force was attained (Δ_{cr}). It should be noted that the comparative test results of phases I and II, verify the sensitivity of the out-of-plane behavior of the walls to the boundary conditions. As expected, due to the beneficial effect of the additional axial load induced by the top support, specimens W1 and W2 significantly outperformed specimens W4 and W5. More specifically, while specimens W1 and W2 showed an increasing strength with displacement, specimens W4 and W5 exhibit degradation on both strength and stiffness.

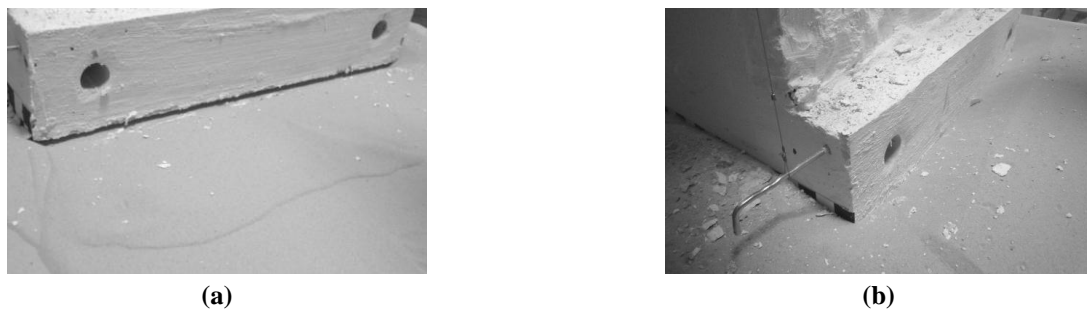
Figure 10. Post-test footing close-up photos: (a) dense sand (evident generated gap), and (b) loose sand.

Foundation rocking gradually led to loss of contact between the soil and the footing close to its edges, where intense uplifting took place, in the case of dense sand. The formed gap, where the footing is detached from the underlying soil, is clearly visible in the close-up photo of Figure 10a which was taken after test completion. Inspection of Figure 9c reveals a recorded arc-shaped soil surface formation beneath the footing of specimen W4. The specific finding proves that the gaps generated at the front and the back of the footing were associated with a reduction of its effective width. The aforementioned phenomenon did not take place in the case of loose sand, where the performance was sinking-dominated. The close-up photo of Figure 10b illustrates that at the end of the test the footing was partially embedded in the loose soil.
